WEEKLY REPORT OF CONSTRUCTION ACTIVITES

Project Name: Beech Grove Greenway Trail
For Week Ending: 1/23/2021
Date of Notice to Proceed: 10/5/2020
Work Days Previously Reported: 25
Contractor: Morphey Construction
Owner: City of Beech Grove

Report No.: 6
Calendar Completion Date: 11/15/2022
This Report: 5 **Total to Date:** 30
Contract Amount: \$ 3,429,000.00
Paid To Date: \$ 334,929.74
Designer: Crossroad Engineers

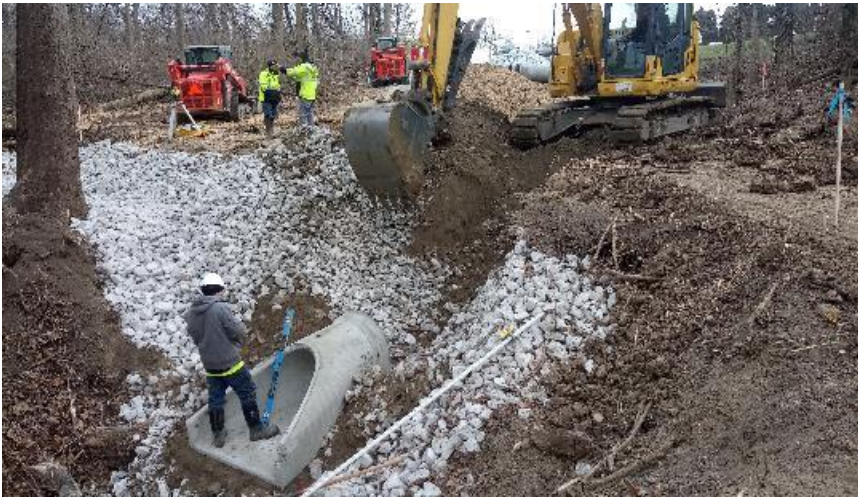
Setting end section at STA: 162+00 north of the Skillman building.

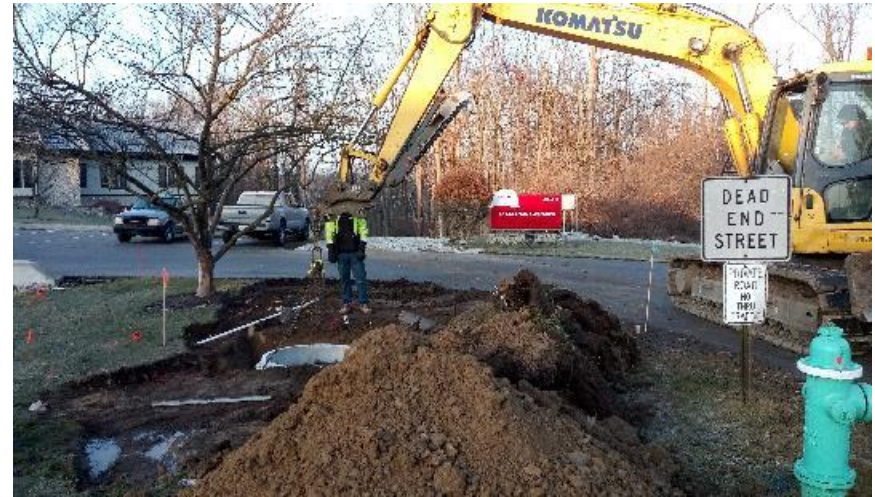
Setting the manhole at STA: 164+75 at the end of Hornet Avenue.

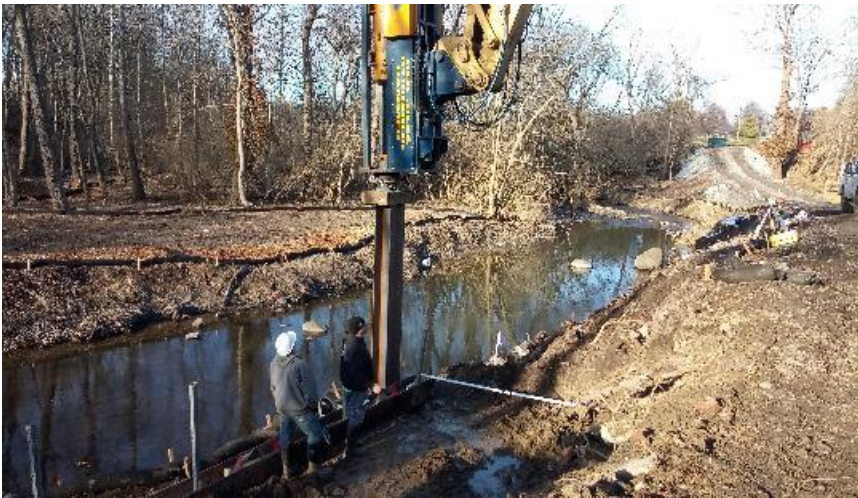
Preparing to drive the steel pile in Bridge #2, bent #1.

Day and Date	Work in Progress	Current Controlling Operations	Reasons for Reporting As a Work Day or Non-Work Day	Fraction of Day Workable	Work Days Charged
Sun 1/17/21	No Work Today	Bridge Pile Driving	Contractor not on-site	0/24	0
Mon 1/18/21	Morphey finished up the storm sewer pipe. The pile driving hammer was delivered today but they were missing parts to connect to excavator.	Bridge Pile Driving	Contractor on-site	10/24	1
Tues 1/19/21	Parts to connect the driving hammer to the excavator were delivered late today. Morphey did drive one pile at Bridge #2, bent #2.	Bridge Pile Driving	Contractor on-site	10/24	1
Wed 1/20/21	Morphey drove the remaining two piles for Bridge #2, bent #2. Next they moved to Bridge #1, bent #2 and drove all three piles.	Bridge Pile Driving	Contractor on-site	10/24	1
Thurs 1/21/21	The excavator was mobilized to the west side of Lick Creek. Morphey drove the three piles for Bridge #2, bent #1. All three met bearing.	Bridge Pile Driving	Contractor on-site	10/24	1

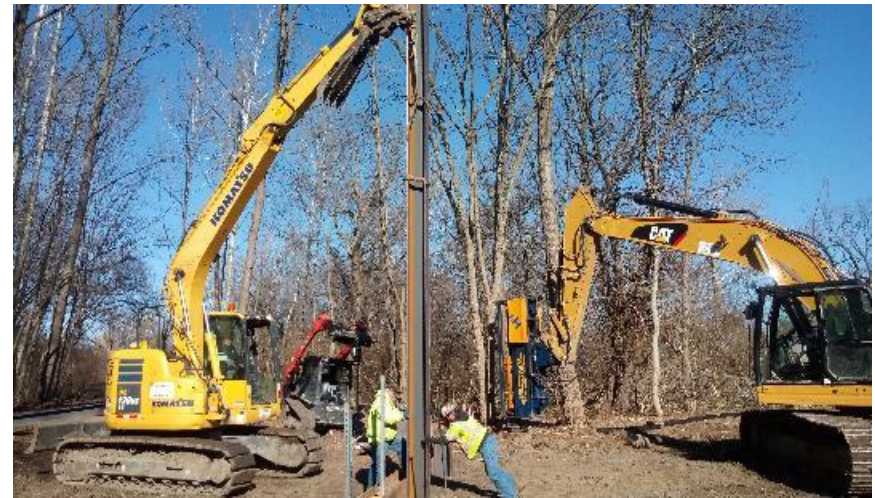
Lining up the steel pile for Bridge #4, bent # 2.

Fri 1/22/21	Morphey set up to drive piles for Bridge #4. They started at bent #2, then moved west of Beech Creek to drive bent #1. All piles met bearing.	Bridge Pile Driving	Contractor on-site	10/24	1
Sat 1/23/21	No Work Today	Bridge Pile Driving	Contractor not on-site	0/24	0
